Accelerator Complex Status

End week 8 (Monday 1 March 2021)

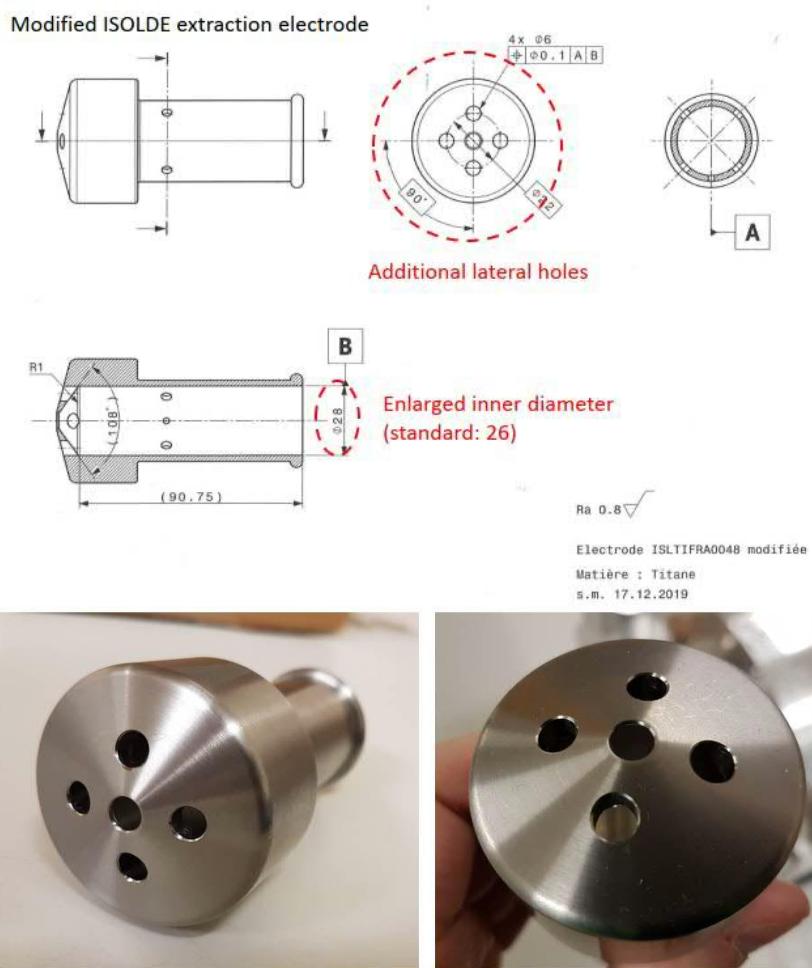
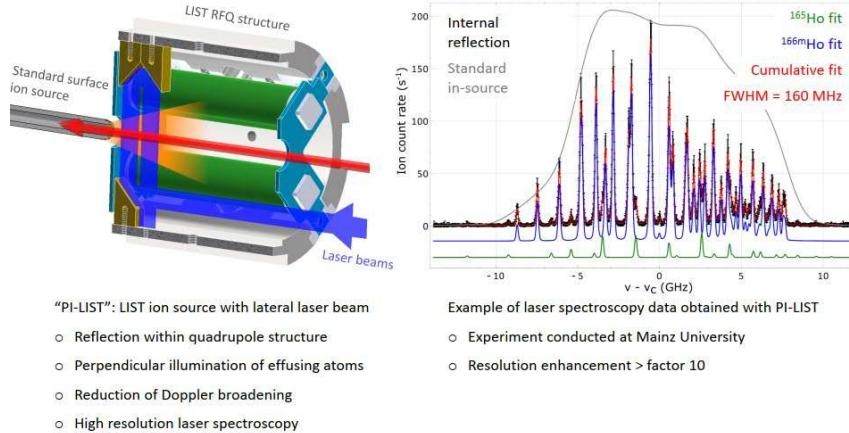
At GPS the main activity was the change of the extraction electrode tip in the new Front-End #10 on Wednesday for a new type with 4 extra lateral holes around the middle one.

The ‘normal’ hole in the middle is used to send the RILIS lasers for ionization and to extract the ions from the target. The four lateral holes can be used by additional lasers when a special type of (PLIST) target is coupled which has reflecting surfaces within a quadrupole structure right after its ion source. The reflected laser beam interacts with- and causes perpendicular illumination of the effusing atoms. The effect is a reduction of Doppler broadening and higher resolution laser spectroscopy. Experiments conducted at Mainz University, where this tip is in operation for over a year, have shown a resolution enhancement greater than a factor 10 (Reinhard Heinke et all.).

Below: The new 1+4 holes extraction electrode tip (courtesy Reinhard Heinke SY/STI):

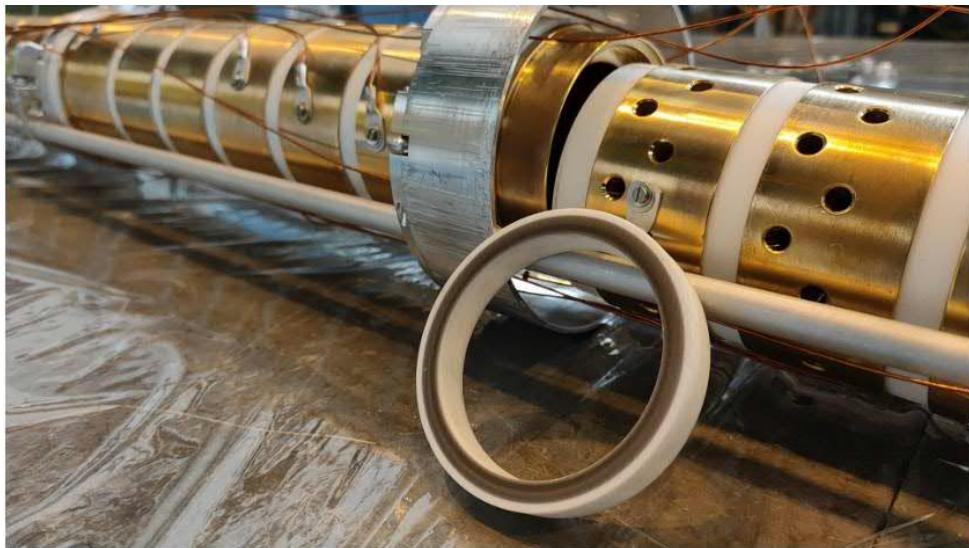
On the REX side work is continuing on the REXTRAP inner structure. Some clear evidence of discharges came alight explaining the effects seen during last years’ recommissioning run. The cause is now being understood and new parts are being made. Another example of how important last

Below: The REXTRAP inner structure with one of the electrode rings clearly carbon coated due to discharges (Courtesy Miguel Lozano Benito BE/OP):

years' restart and recommissioning run has proven to be. We are confident to have the REXTRAP back in good shape in time for the '21 REX/HIE run.
